PHASE I and II ARCHEOLOGICAL INVESTIGATIONS
of the
STANTON INTERSECTION

STANTON, NEW CASTLE COUNTY, DELAWARE

DELDOT
ARCHEOLOGY SERIES NO. 32

**PHASE I & II ARCHEOLOGICAL INVESTIGATIONS
OF THE
STANTON INTERSECTION, NEW CASTLE COUNTY, DELAWARE
DELDOT PROJECT 82-101-02 ARCHEOLOGY SERIES NO. 32
FHWA FEDERAL AID PROJECT F-1045(15)**

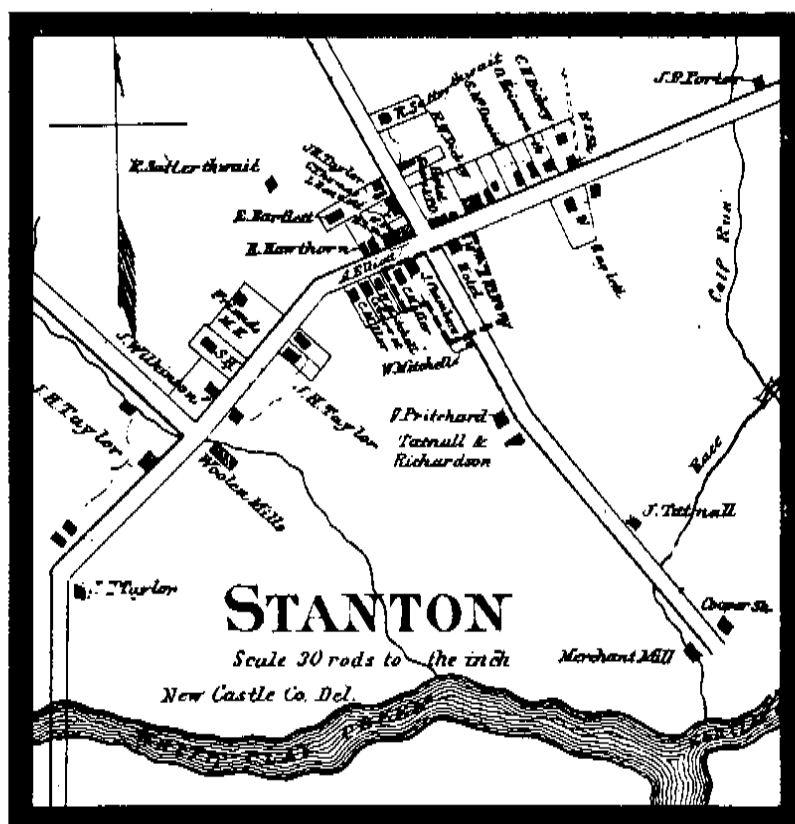
FIGURE 8

BEER'S ATLAS MAP OF STANTON, 1868

KEY:

----- C. Miller, J. Chambers, and Wm. Anthony Hotel Lots

"Miller Lot" (as designated on the Beer's Atlas map 1868, Figure 8), and that on the northwest will be called the "Church Lot" after its present function. Other geographical points of interest in the project area will be identified in the course of the discussion.

It was initially thought that the lot on the southwest corner of the intersection corresponded to the lot labelled "J. Chambers" on the 1868 Beer's Atlas map of Stanton (Figure 8). Documentary and field research revealed, however, that most of the Chambers Lot was covered by road construction when the "Mill Road Connector" (Mill Lane) was widened during construction after 1966 (see Figure 9). The earliest reference to the Miller Lot was in a deed in the New Castle County Courthouse (T3-155, 1816 -- this and all subsequent deed references are of this form, where the volume, or "docket" is given first as a letter and numeral, followed by a dash and the page number within the volume. All documents are in the New Castle County Property Records in the "City County Building" in Wilmington, though the earlier ones may also be found on microfilm at the Delaware Hall of Records in Dover). This deed transfers about one and a half acres from John Stapler to Francis Denny. It refers to the will of Thomas Stapler, in which a three acre tract was given (undivided) to John Stapler and his brother Stephen (this will could not be located). The Sheriff had sold Stephen's undivided half interest to Denny to pay off Stephen's creditors, and this deed divides the original three acres into halves, John Stapler retaining the southern half, and Denny receiving the northern half. The description makes it fairly clear that Denny's portion is bounded on the east by Mill Lane and on the north by the Newport Turnpike.

None of the property transfers describe any improvements on the lot, nor do they positively establish that any of the owners actually lived on the lot, though the Beer's map (1868, Figure 8), and the Hopkins' map (1881, Figure 11) both show a structure on the second property west of Mill Lane labelled "C. Miller". The Baist map (1892, Figure 12) likewise shows a structure in this location.

In summary, occupation of the lot cannot be established prior to the Beer's Atlas map of 1868 (Figure 8), but some of the earlier owners (Thomas Stapler and his sons) are likely connected with some of the earliest activities at Stanton. Other owners will appear referenced below, reflecting the interaction typical of a small community (see Table 1).

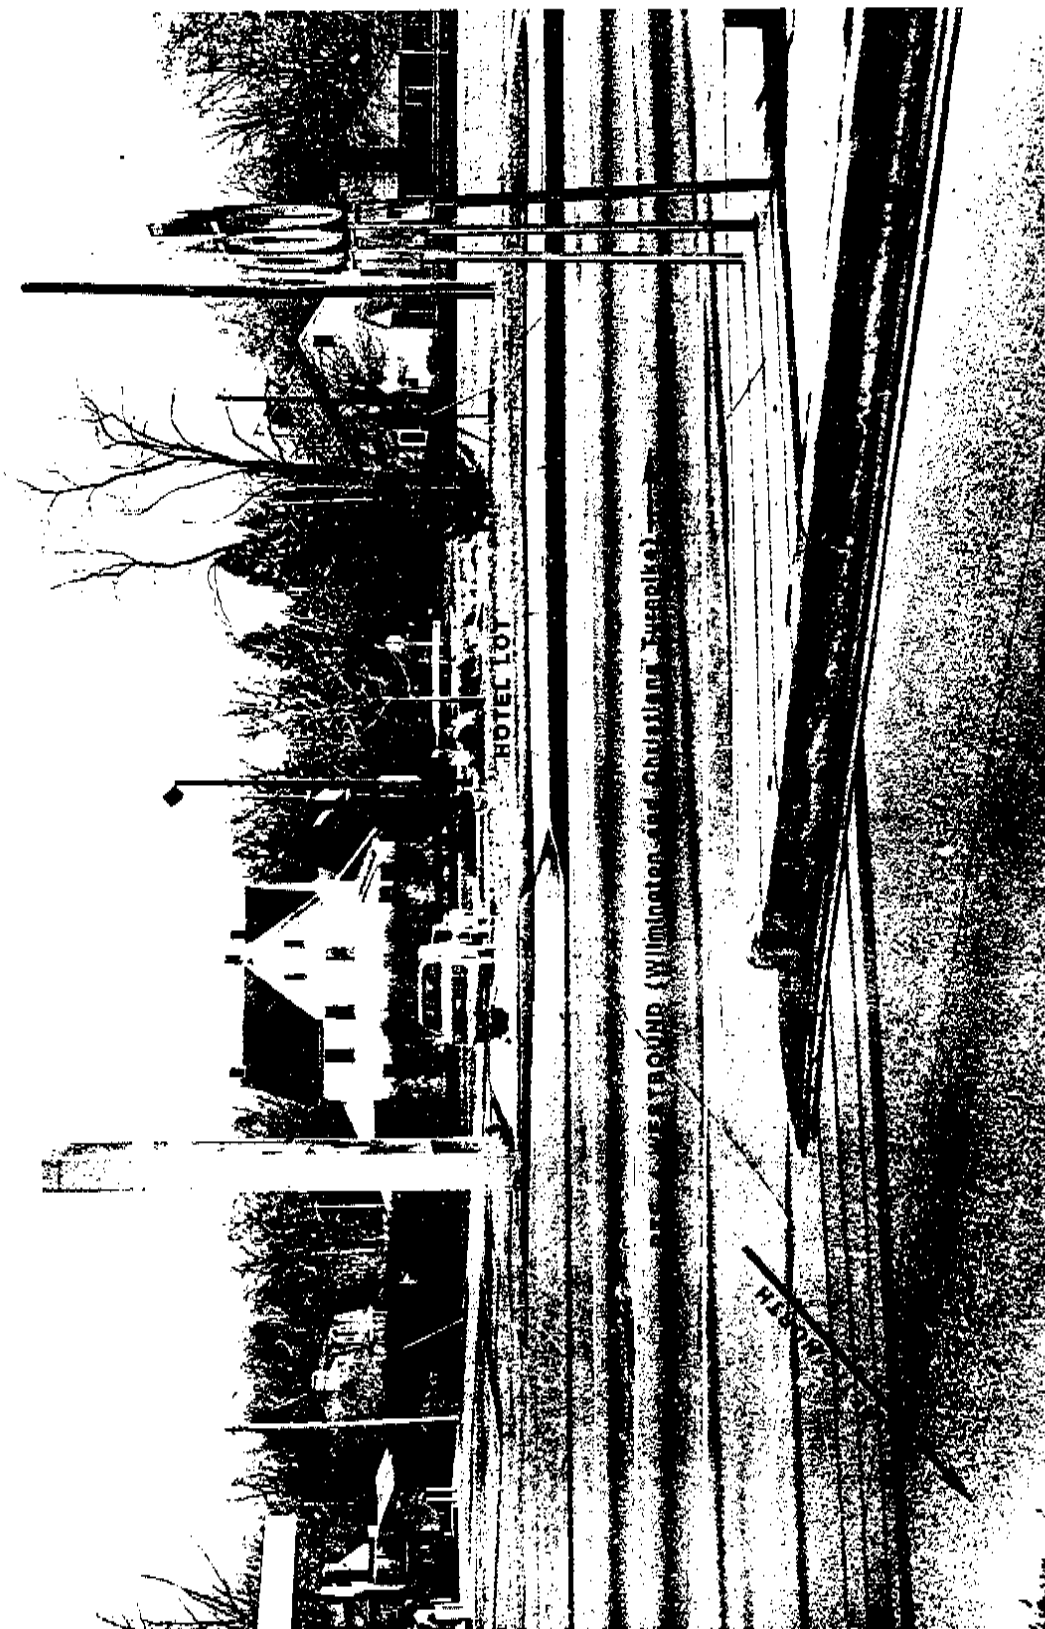
PLATE 1

The boundaries of the Hotel Lot are taken to be the boundaries specified in the deed transfer from Solomon Hersey to John Narvel in 1888 (Figure 13), F14-479). These include most of the block between Mill Lane and Elm Street, to the east (Plate 1). They exclude the northeast corner of the block which the deed states was a lot "lately sold to Louise Neville". The degree to which archeological

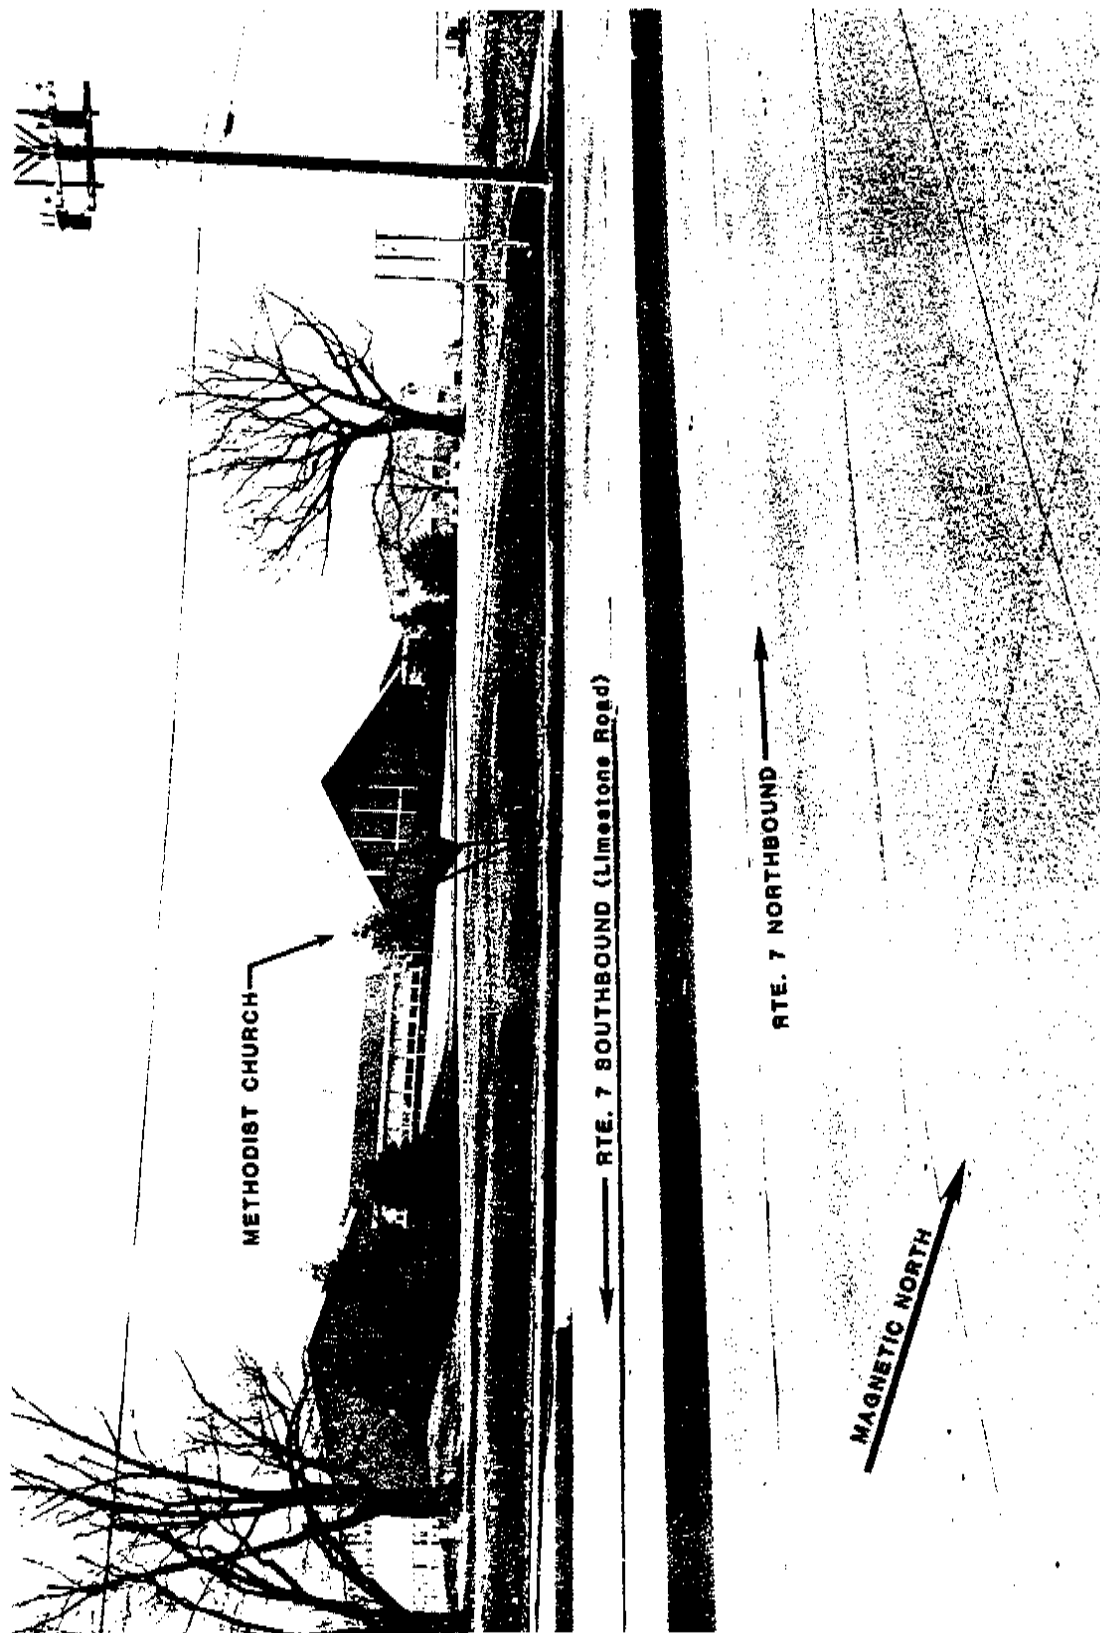
PLATE 4

For reasons described previously, this area received relatively less attention than the others. The impact zone will cut a narrow path along the west side of Limestone Road, roughly parallel to the present curb line (Plate 4). In effect, it will broaden the curve of the access ramp from Limestone Road onto Route 4,
